**RE: 505 1st Street, Milford, Nebraska  
City Hall**

Pursuant to your request, Structural Design Group performed a visual observation of the aforementioned property on July 10, 2006. The purpose of the observation was to determine the reasons for the noticeable settlement near the front vault area and provide an overall observation of the existing building structure. Destructive examination and the observation of the roof framing or members were not within the scope of services.

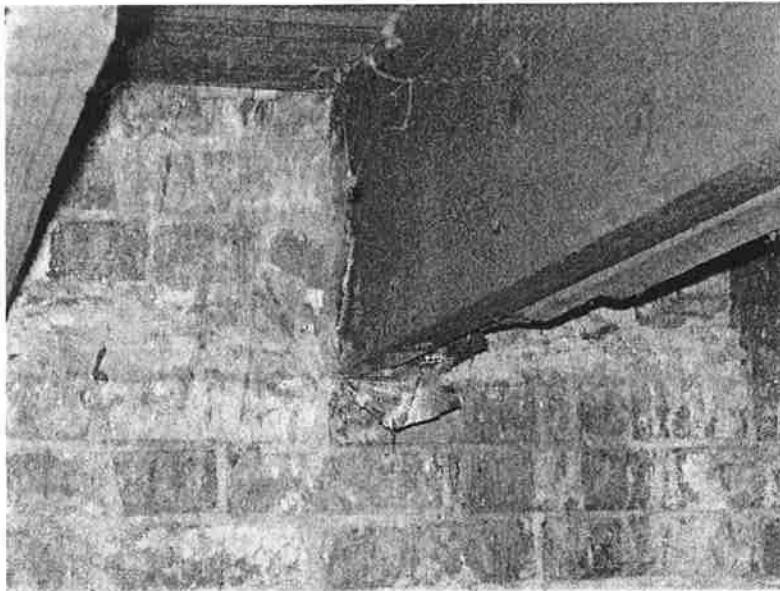
An effect this moisture has on the structure is the deterioration of any wood that is in contact with the wall. In the original building and additions the wood floor joist are "toothed" into the wall. Specifically along the east wall of the original building this can be seen with the result being the visible settlement of the floor around the vault area.

Figure A. Crawl space joist at deteriorated bearing.

Extensive remedial work in the form of removal and replacement of the masonry walls that are currently showing excessive signs of moisture infiltration will be required to insure their future stability. The floor joists that have experienced the deterioration due to the moisture will need to be replaced. Interior bearing headers that do not meet the design requirements will need to be replaced with solid bearing to a suitable foundation element.

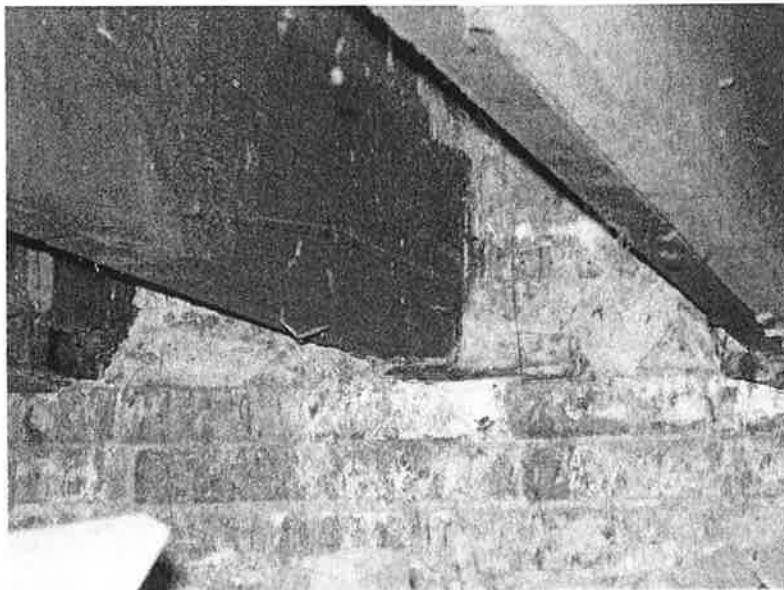
A significant portion of the original building's exterior walls exhibit efflorescent stains. This occurs when masonry becomes saturated and the moisture dries out

the soluble salts which are left behind as a deposit on the face of the wall. Most often these deposits are found to emanate, not from the brick, but from the mortar joints. As this continually occurs the masonry and mortar deteriorate and break apart. In all cases, brick and mortar remnants were observed at the base of the wall.

Figure B. Crawl space joist at deteriorated bearing and wall efflorescence.

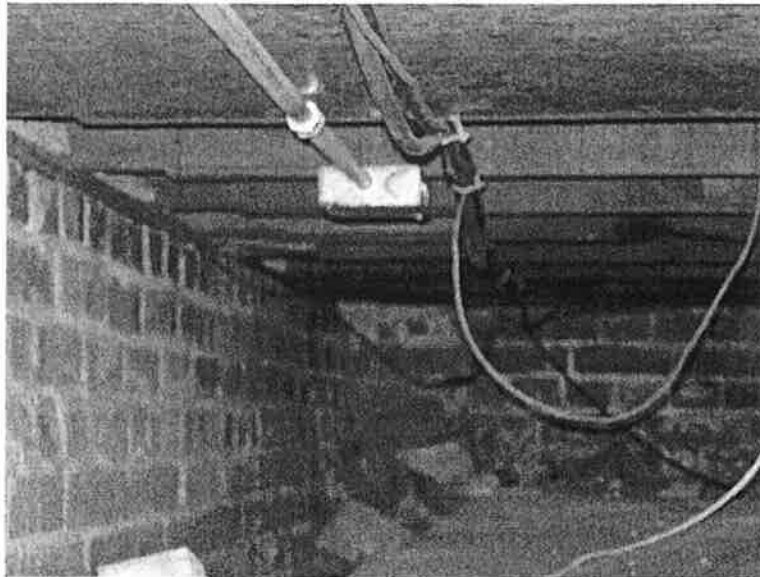
Figure C. Crawl space joist at wall efflorescence and deterioration.

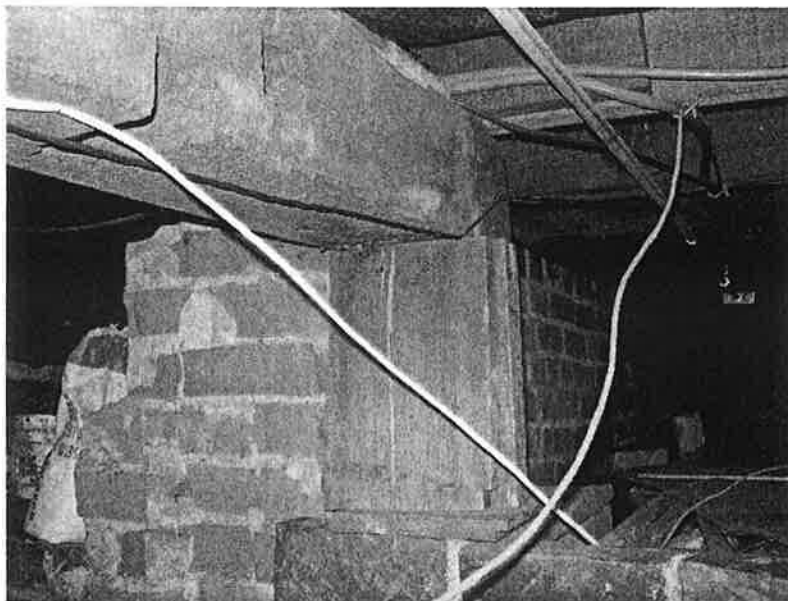
Figure D. Floor joist bearing at header condition in original building.

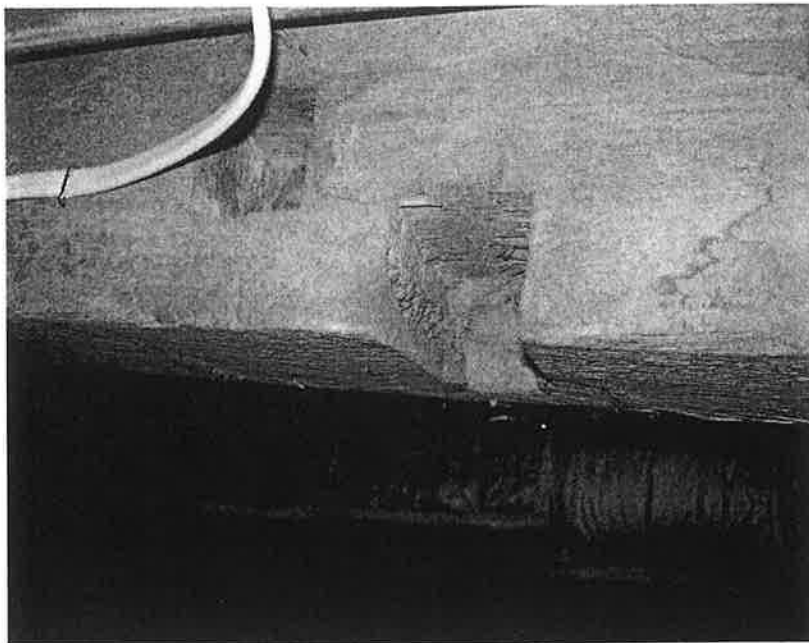
An existing undersized wood header acts as an interior bearing support that has notches and drilled holes throughout its span. The bearing condition consists of (2) 2x10's that are wedged between the bottom of the joist and the single wythe masonry wall. This load has caused considerable cracking in the wall.

Figure E. Existing load bearing header.

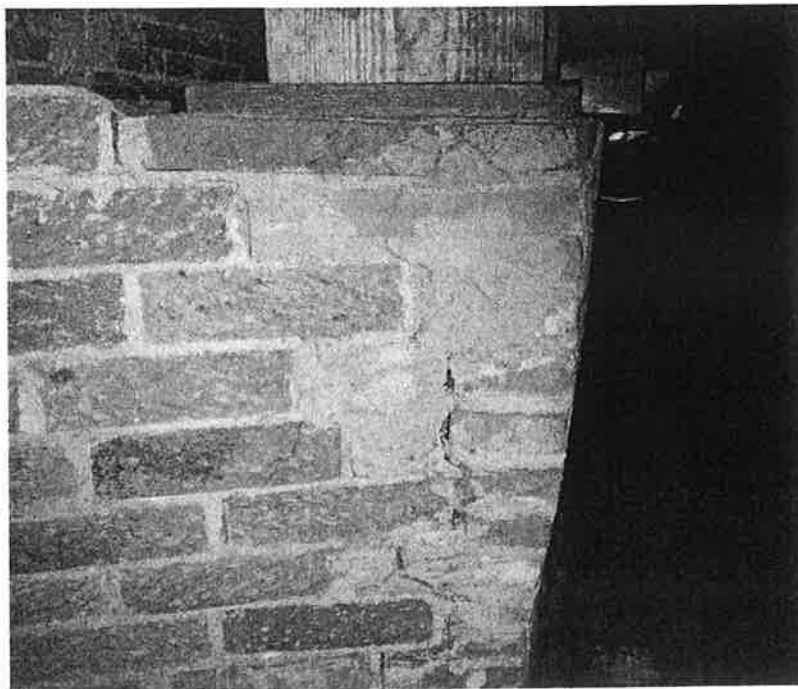
Figure F. Header bearing on single wythe masonry wall.

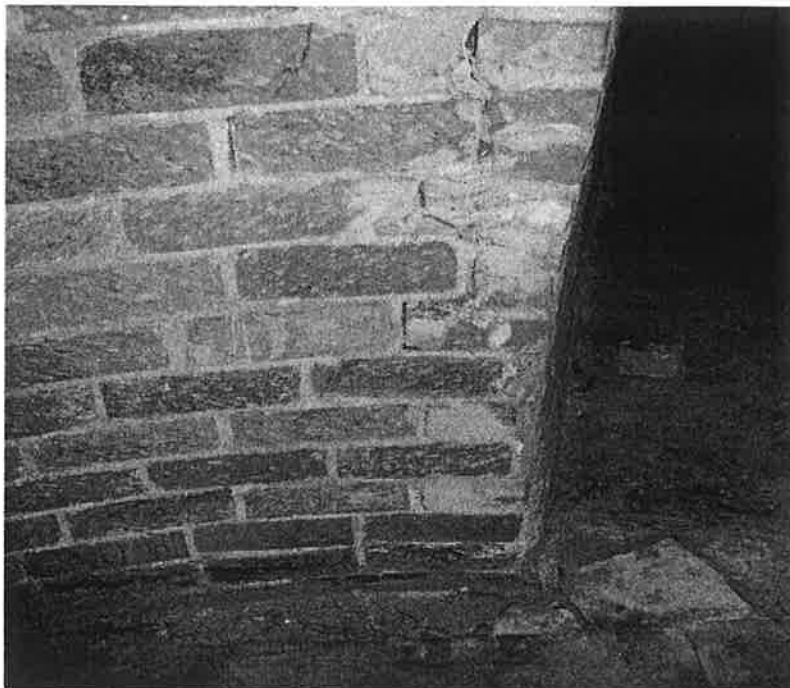
Figure G. Crack propagation through wall at header bearing.

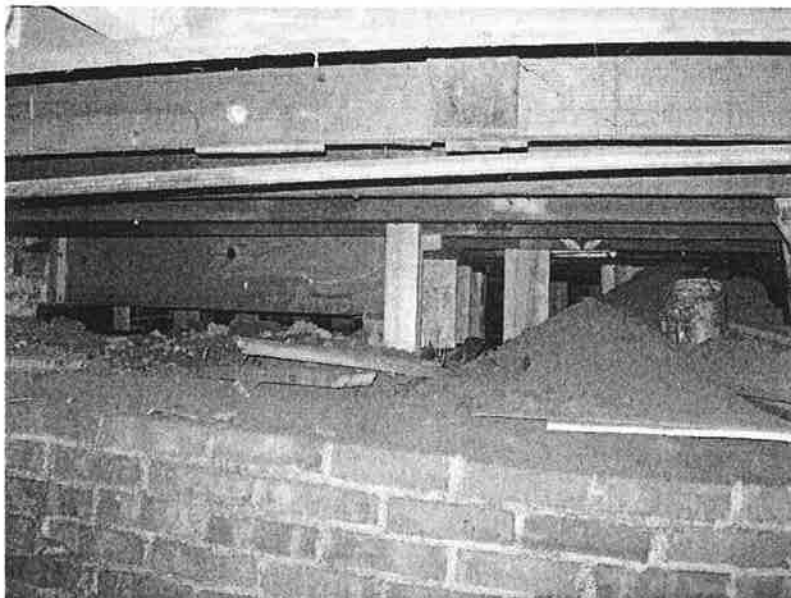
Figure H. Altered floor framing for ramp addition.

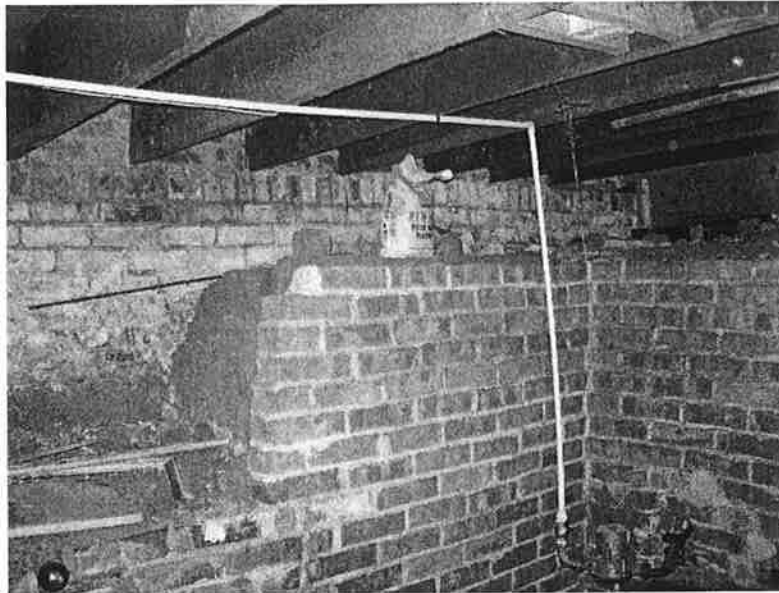
The single wythe brick wall that forms the perimeter of the partial basement under the original building is failing with multiple cracks throughout the wall and horizontal movement at the top of the wall. It is currently acting as a retaining wall, but it has no capacity to resist the loads imparted on it. There does not appear to be any type of foundation under this other than the concrete slab-on-grade floor system.

Figure J. Single wythe retaining walls in partial basement.

If the partial basement in the original building is to be kept, the existing single width masonry wall should be removed and replaced with reinforced cast-in-place concrete or concrete masonry unit walls. Either option shall be designed according to required lateral pressures taking into account the possible adjacent footing loads that are occurring.

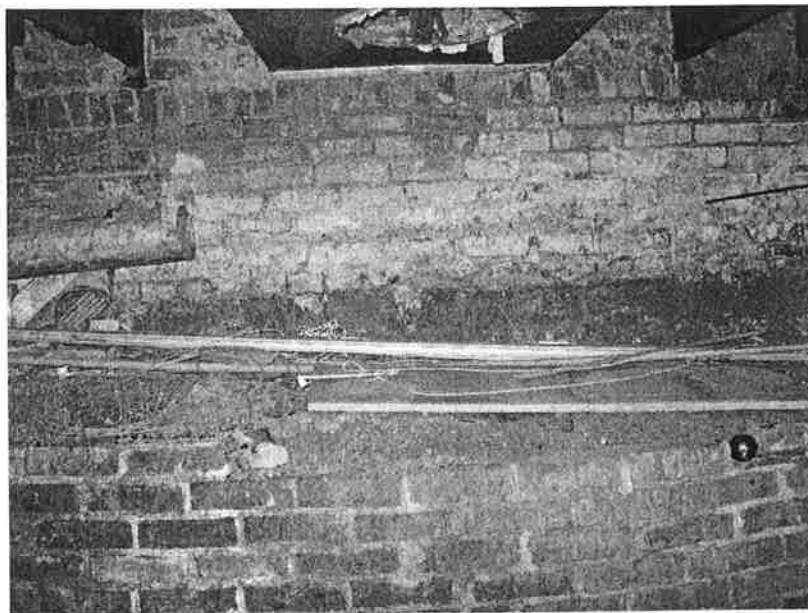
Figure K. West exterior bearing wall in original additional above partial basement elevation with signs of moisture seepage.

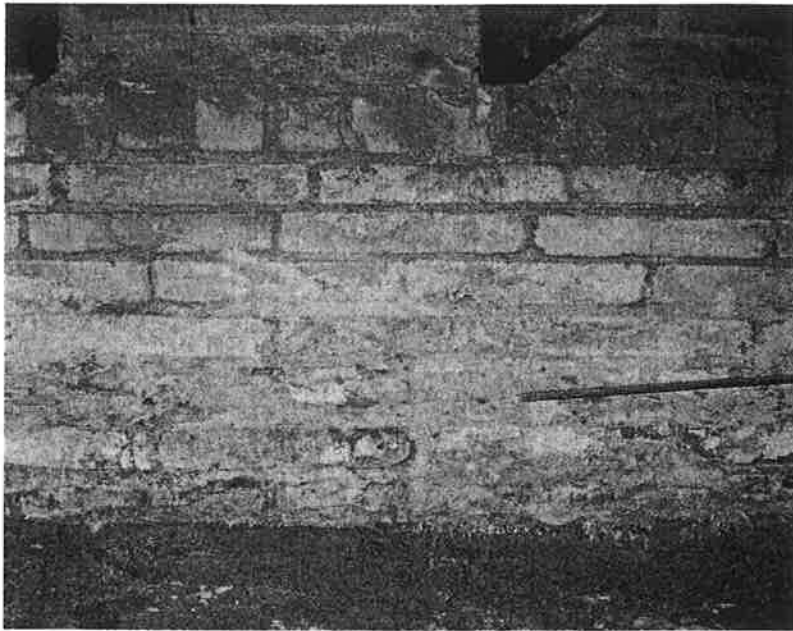
A portion of what appears to be the footing of the west exterior wall is visible and it is located above the single width brick retaining wall. This creates a substantial lateral load on the wall that it is not designed to resist. Again, through this exposed area, efflorescence is visible and the deterioration of the wall is evident based on the build up of mortar and brick remnants at the base of the wall.

Figure L. West exterior bearing wall exposed footing with efflorescence and deterioration.

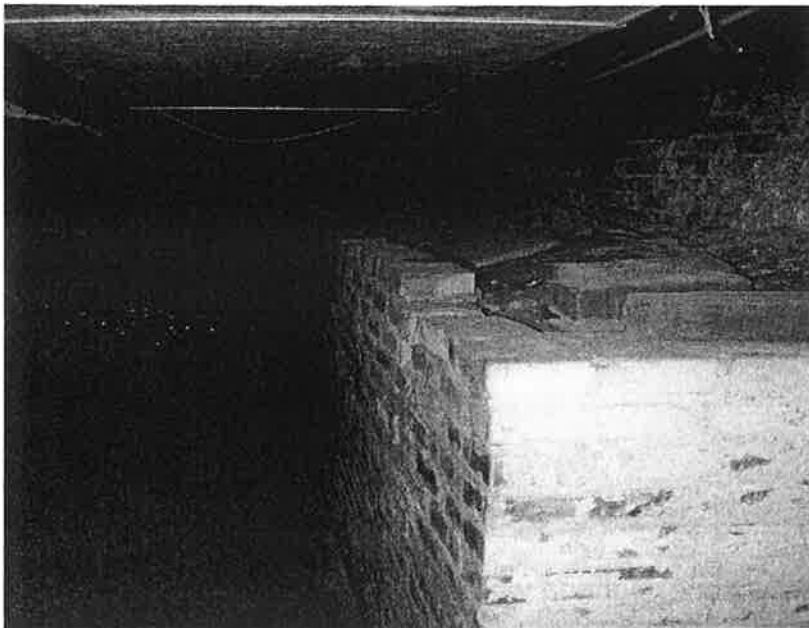
Figure M. East single wythe masonry wall next to vault.

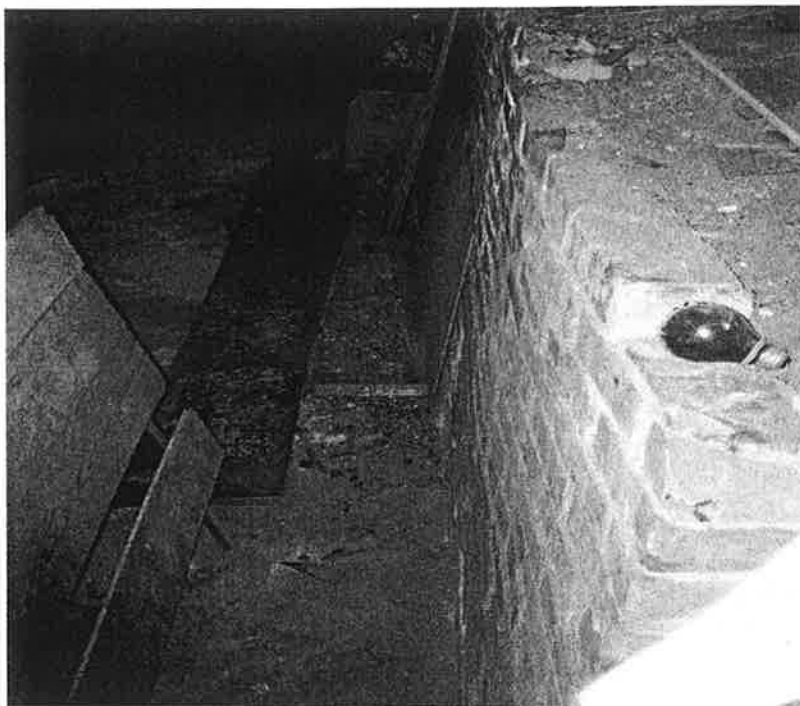
Figure N. West single wythe masonry wall next to vault.

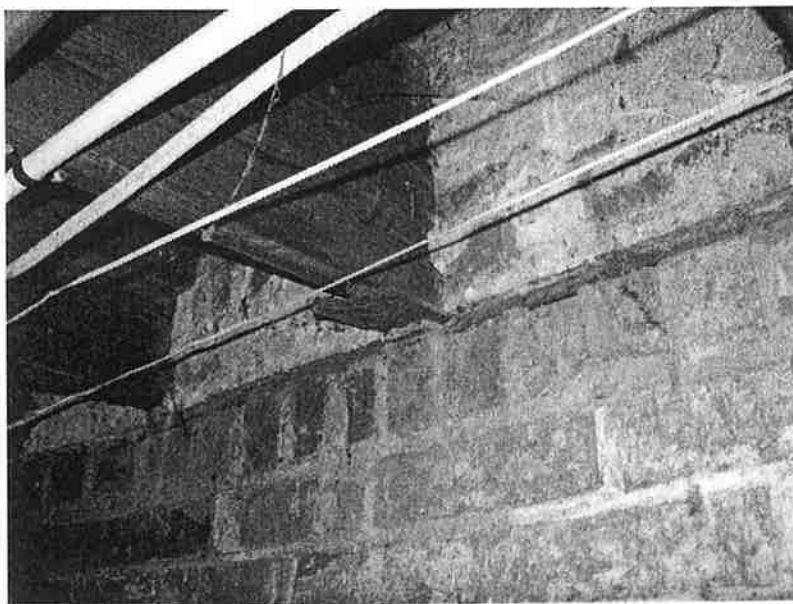
Figure O. Joist bearing on vault wall.

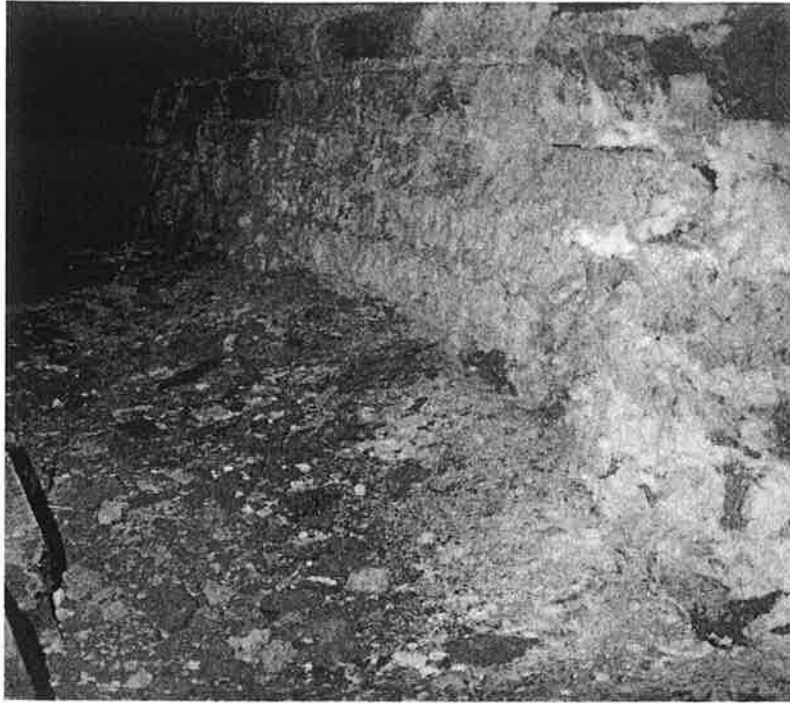
Figure P. Vault bearing with efflorescence and deterioration.

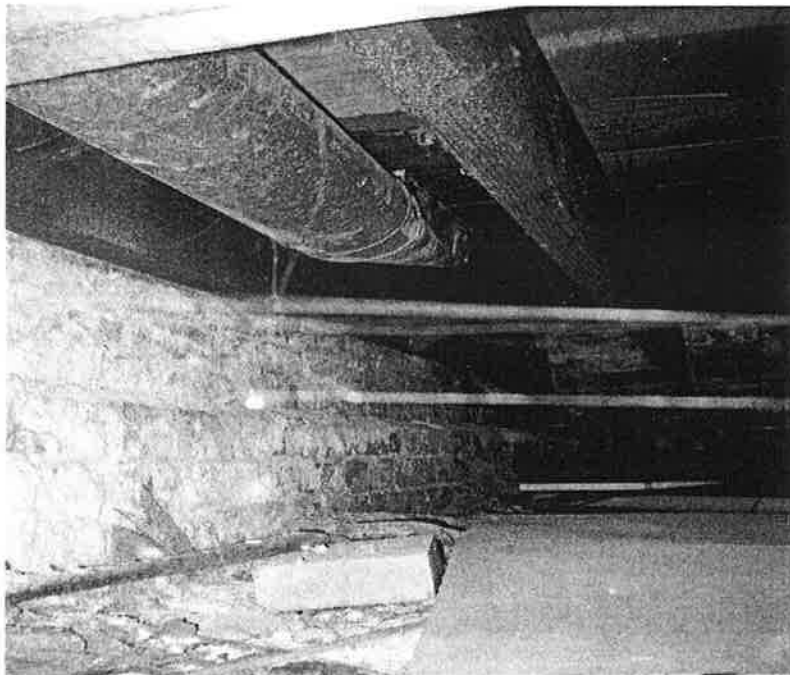
Figure Q. Southern vault wall in bathroom plumbing chase with efflorescence and deterioration.

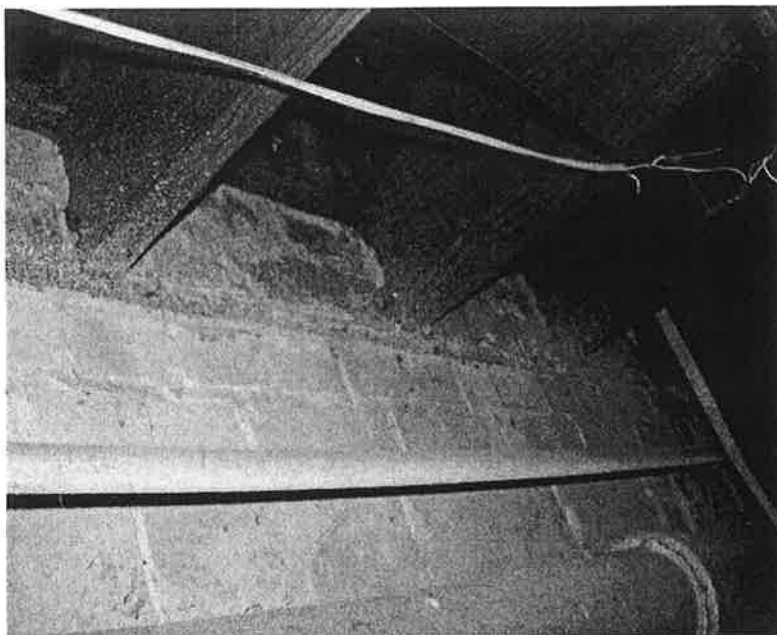
Figure R. 1<sup>st</sup> addition joist bearing at vault wall.

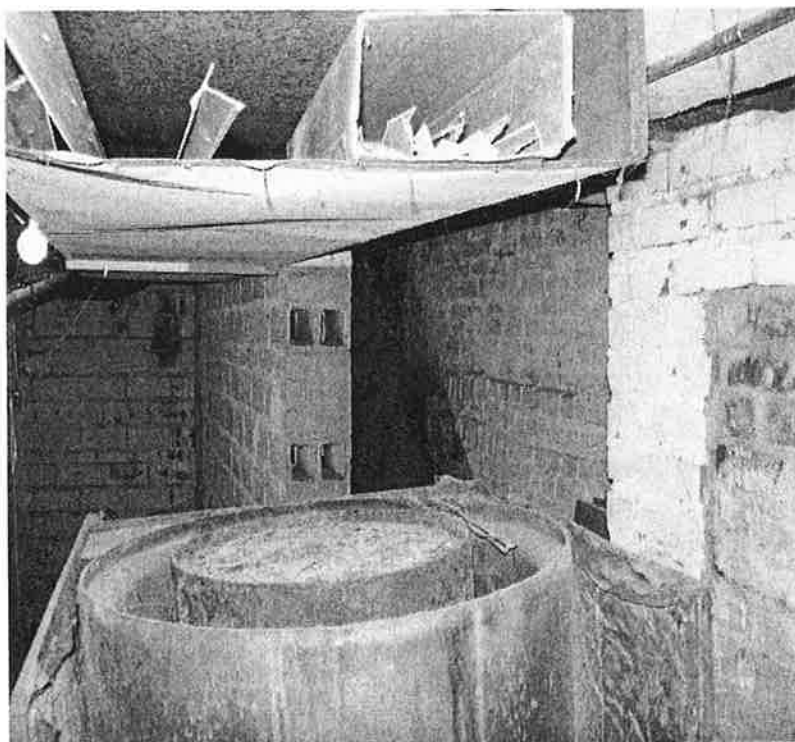
Figure S. 1<sup>st</sup> addition south and intermediate bearing wall at infilled coal/stair shaft.

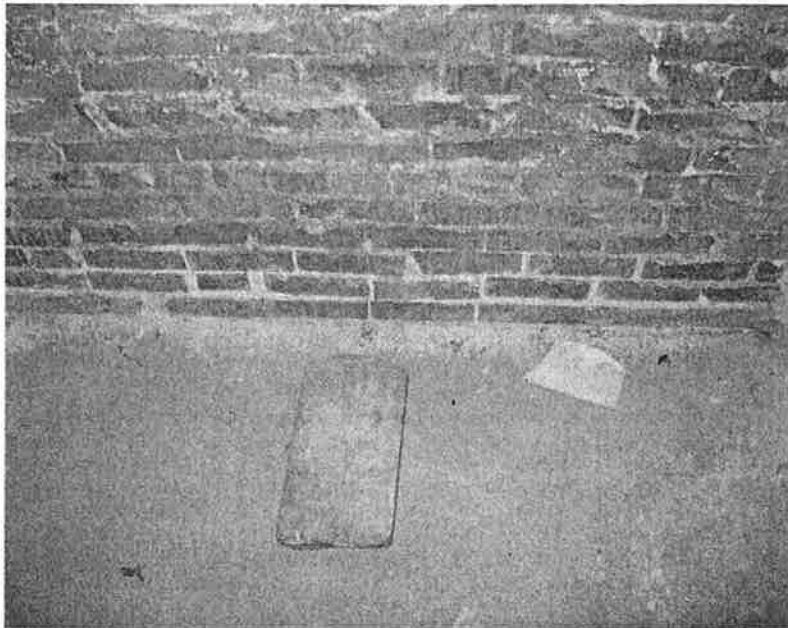
Figure T. Deterioration of 2<sup>nd</sup> addition north wall.

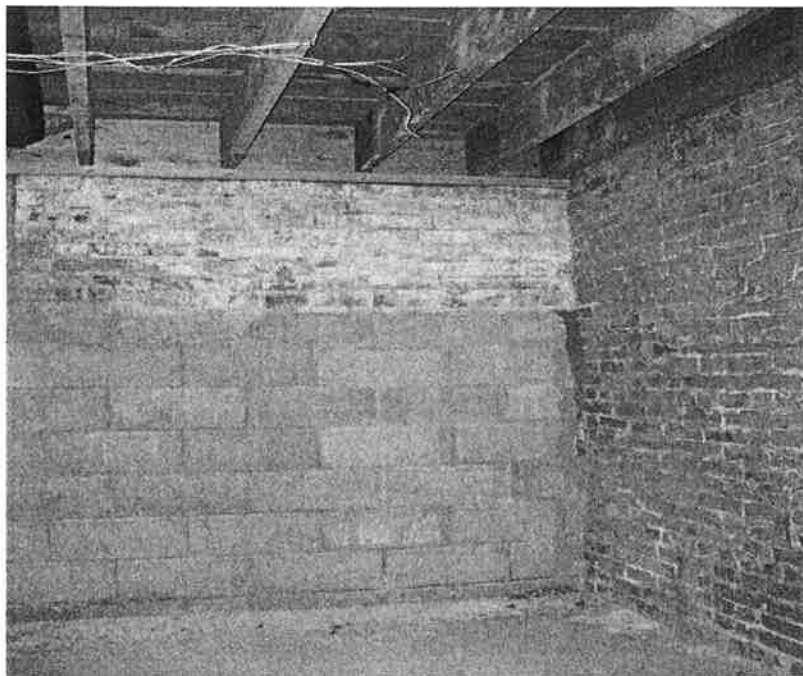
Figure U. West concrete masonry unit wall supporting existing brick masonry wall.

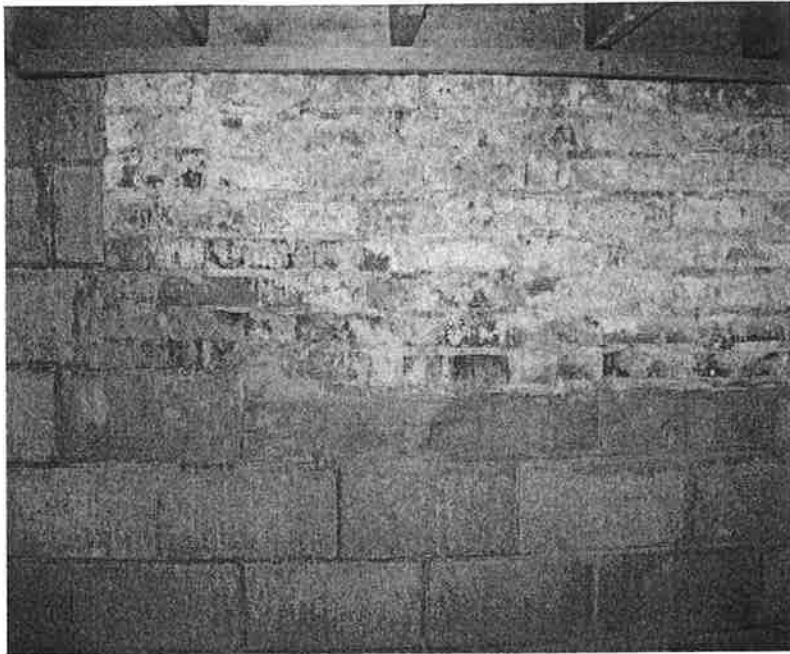
Figure V. Deterioration & efflorescence of existing supported masonry wall.

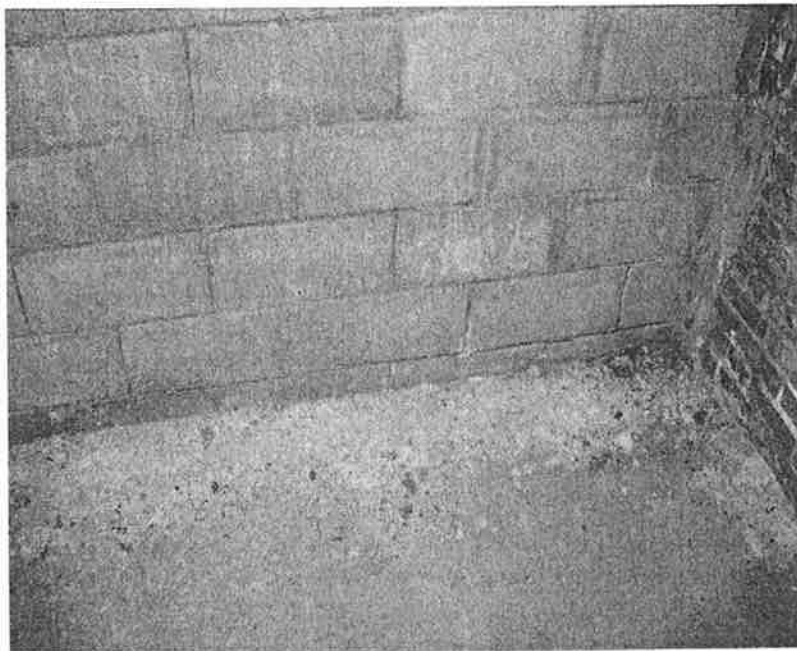
Figure W. Remnant brick and mortar below deteriorated wall.

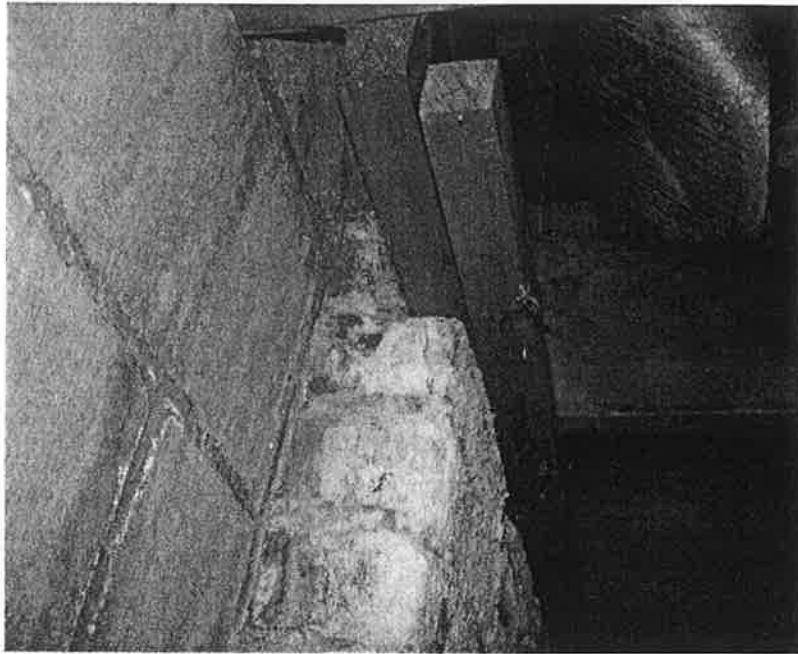
Figure X. Joist bearing along deteriorated wall.

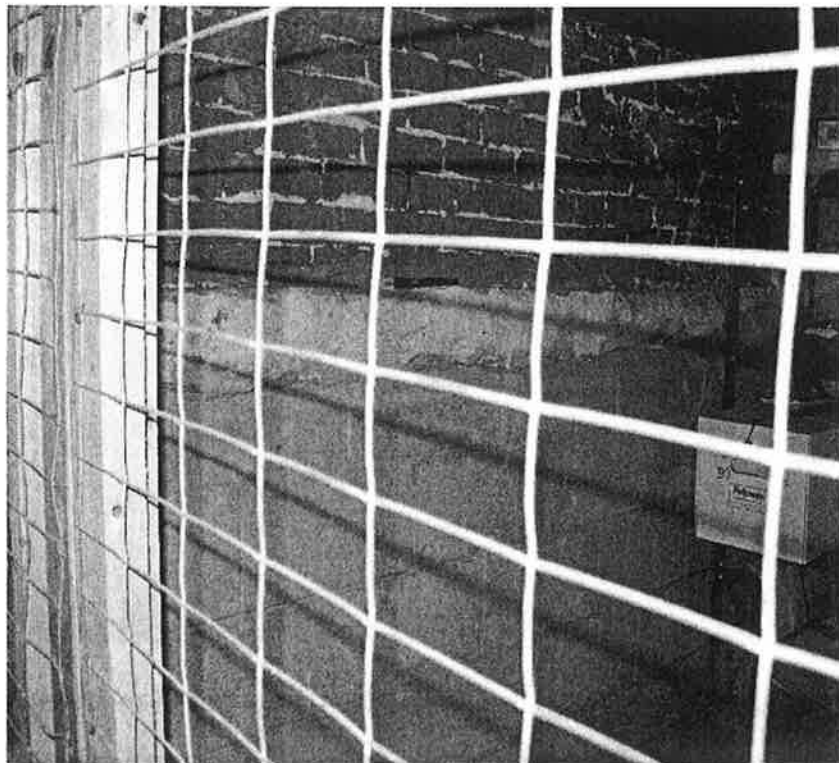
Figure Y. Vault for supported by new c.m.u. wall.

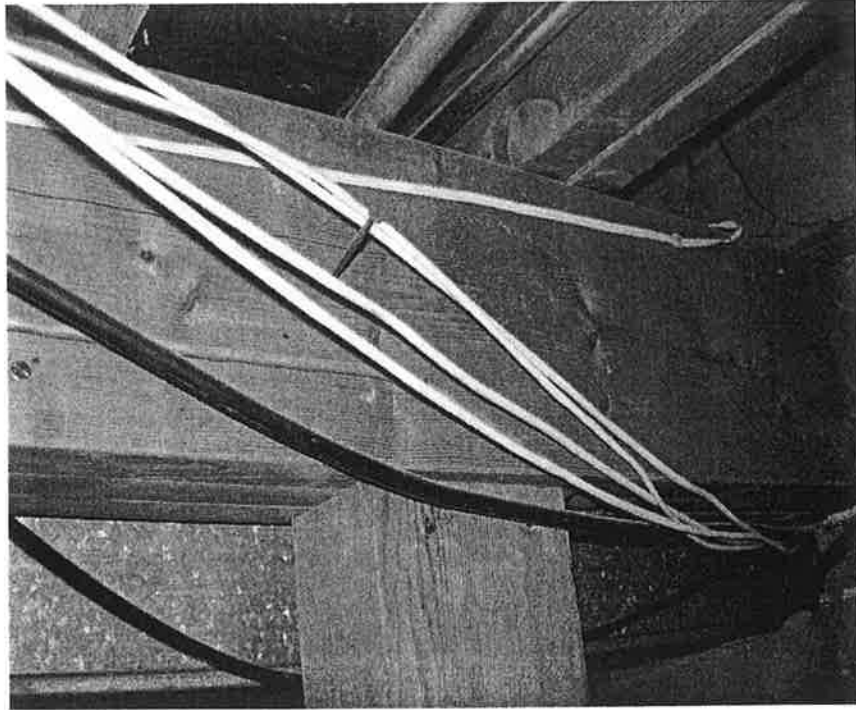
Existing wood beam that spans the second addition is undersized for the considered first floor live load. At this time it is not known if the roof system contributes any load to this. The existing 4x6 wood columns have no positive connection to the floor or footing.

Figure Z. Wood header beam supported by wood column.

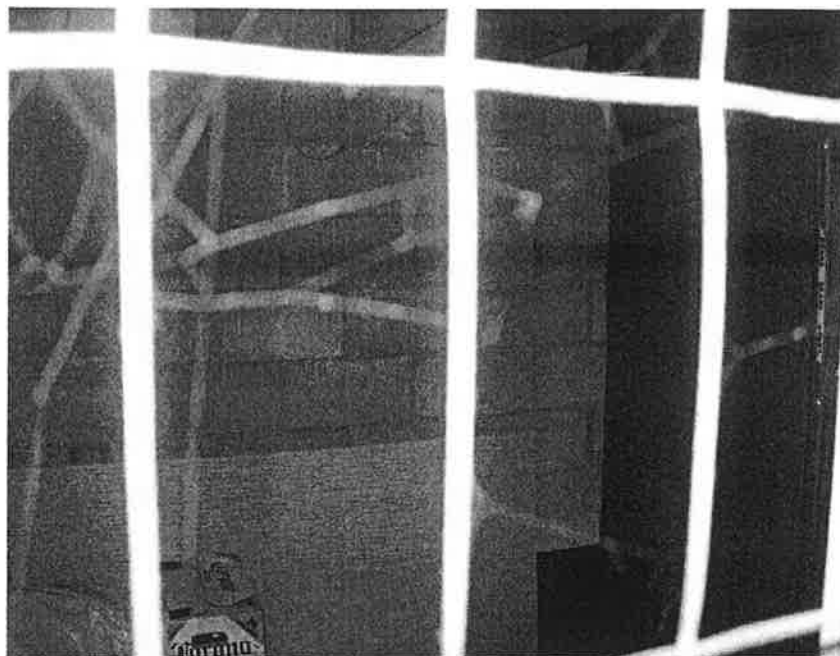
Figure B1. 2<sup>nd</sup> addition east bearing c.m.u. wall.

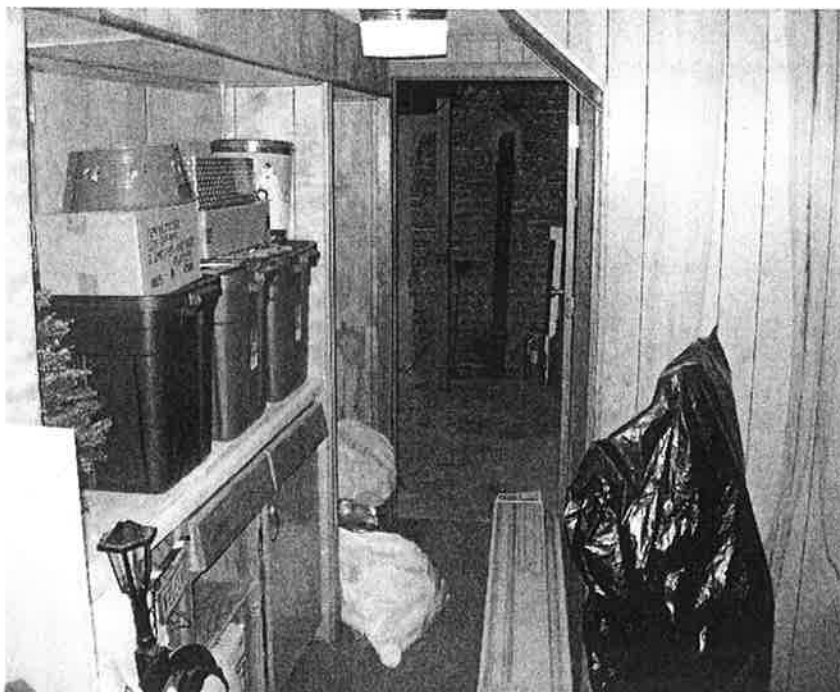
Figure C1. 2<sup>nd</sup> addition corridor entrance into the 1<sup>st</sup> addition.

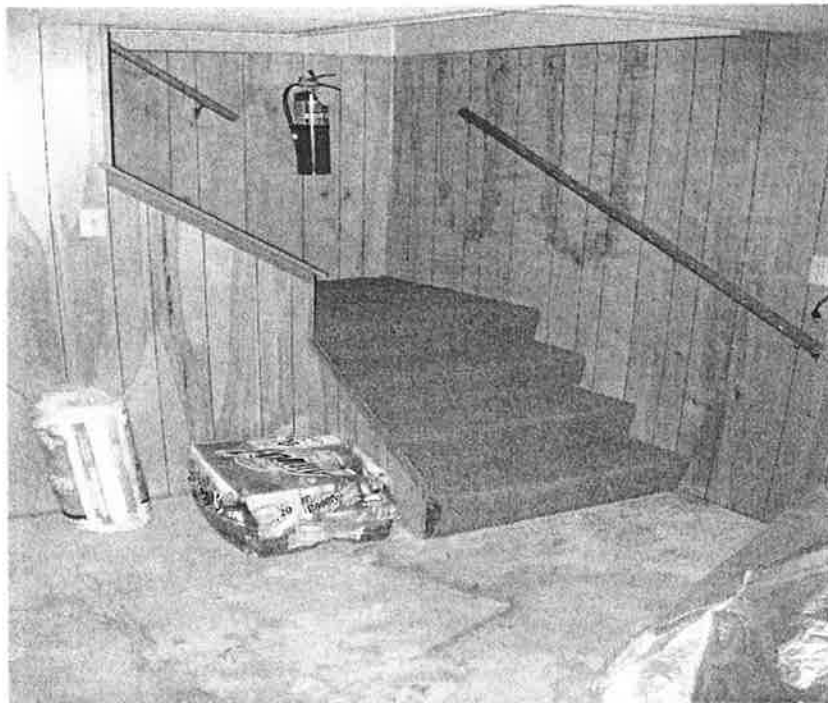
Figure D1. Stair entrance into the 2<sup>nd</sup> addition basement.

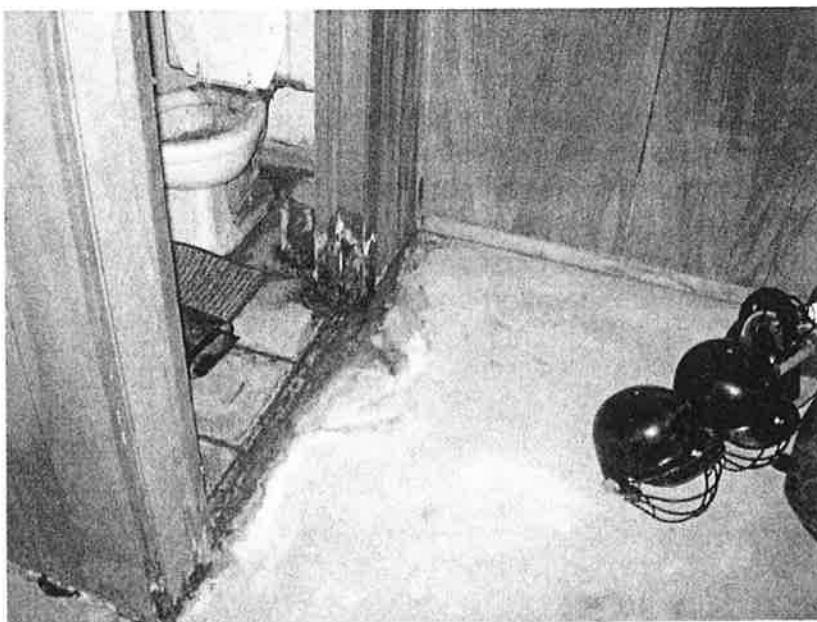
Extensive water damage is apparent around the bathroom facility. Prolonged exposure to this type of moisture can lead to mold and rotting issues.

Figure E1. Water damage to bathroom and surrounding area.

Removal of the furring studs in and around the bathroom should occur to investigate the possibility that the structure has been compromised by water damage.

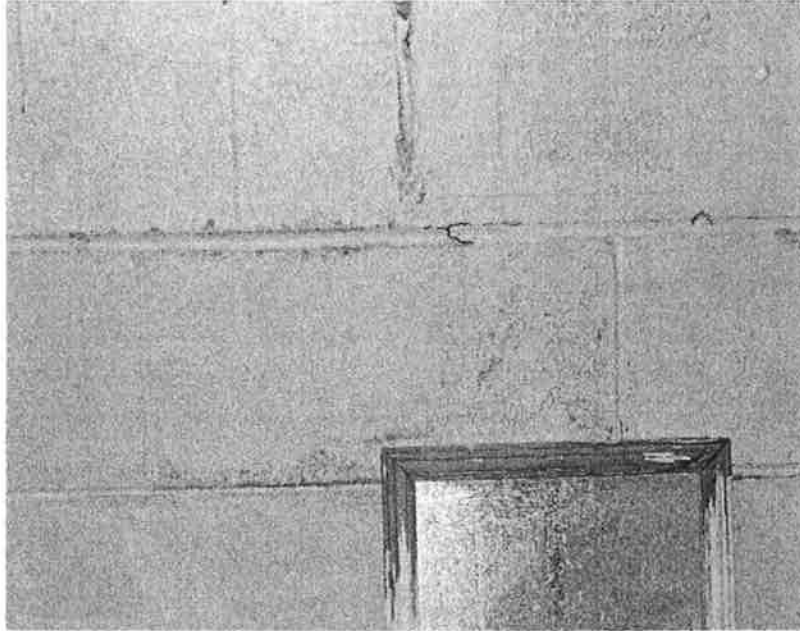
The east concrete block wall is showing signs of moisture through staining and the "blistering" of the paint. The extents of the damage are not known and were not observed in any other exposed location in this area. Note that the south wall is furred out by a wood stud wall.

Figure F1. Moisture apparent through paint “blistering” in bathroom area.
